## AZIPOD PROPELLER BLADE CAVITATION OBSERVATIONS DURING SHIP MANEUVERING

A.V.Pustoshny, S.V.Kaprantsev

Krylov Shipbuilding Research Institute, Russia, St.Petersburg

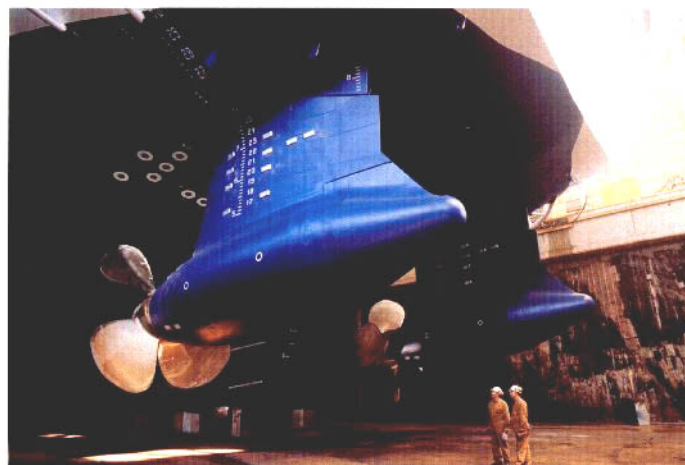
Fig. 1

Considering these features the team had to evolve an observation technique that was somewhat different from the one normally used for conventional propellers. It has soon become obvious that one should consider the effects of maneuvering-related factors upon cavitation patterns as a continuous time series of cavitation pattern variations and make practical conclusions on the basis of such observations. With the propeller so often disappearing from the field of view, the team had to reject the standard photographing procedure since any photos could only show some random positions of the propeller at random instants of pod turning at a particular dynamic condition. The choice was to carry visual observations and video taping. The observers checked the tape quality by a TV monitor installed in the water tank that has been allocated for the observation room and fitted with seven view ports (Fig.1). Subsequently, the videotape was computer-processed to get clear still pictures of individual cavitation patterns associated with maneuvering. Since the propeller was frequently escaping from the camera eye, in order to compile the true cavitation development picture it was necessary to utilize some indirect signs of cavitation on the invisible part of the propeller disk.
